**State of Practice in Seismic Rehabilitation of Buildings and Fragility  
Analysis of RC Columns Retrofitted with FRP**

**Thesis**

The University of Texas at Austin

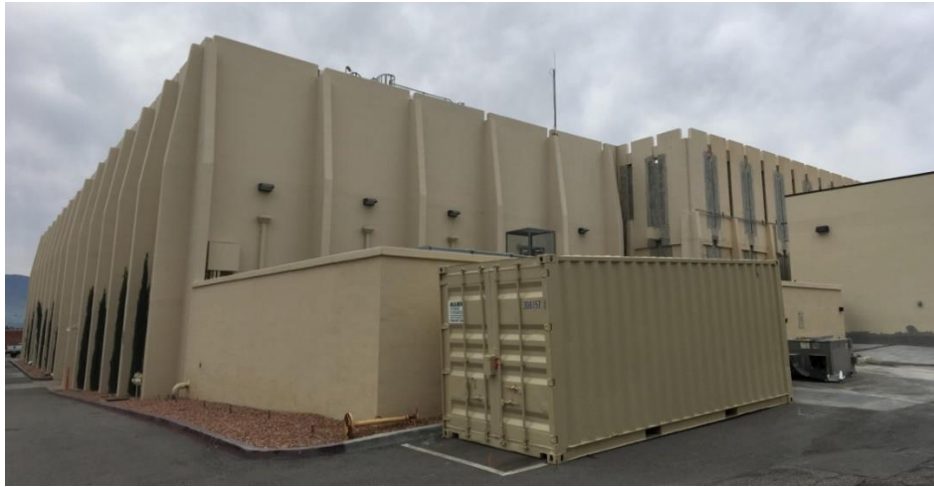
Figure 2.11. General view of the power plant: chiller facility (left building) and steam plant (right building)

Building B is a steam plant that serves a medical center in the San Bernardino area in Southern California. The original structure has a rectangular plan with four reinforced concrete walls in the perimeter. Figure 2.10 presents a general plan of the power plant complex with the steam plant in the bottom right corner. Figure 2.11 presents a general view of the power plant.

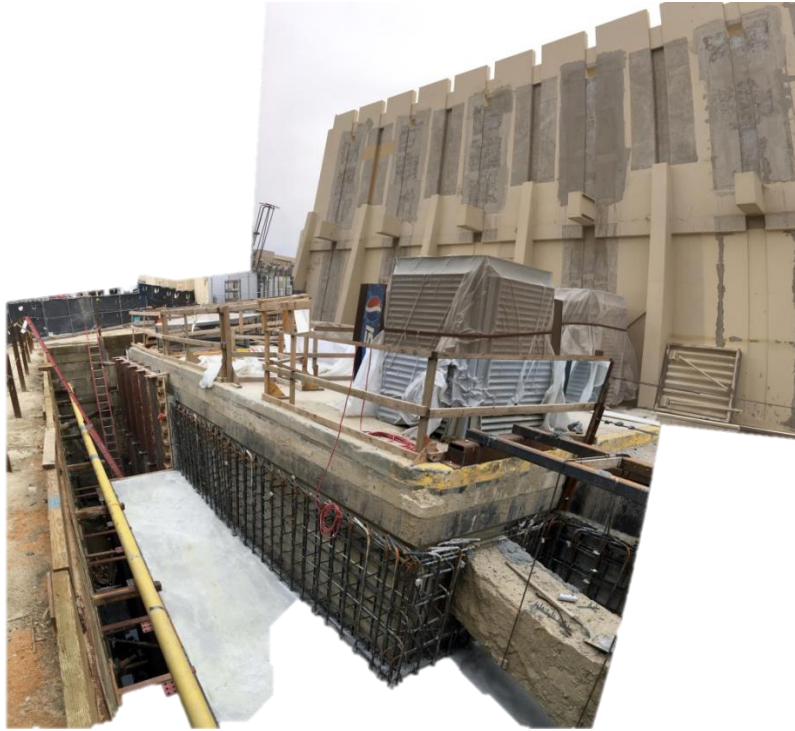
Figure 2.15. View of the wall attached to the foundation and the infills in the shear walls.

The shear walls in the perimeter of the steam plant will introduce higher forces to the existing foundation, which was an old and brittle structure. New piles were required to carry these forces. The strengthening plan includes a wall in the perimeter at the level of the foundation, for the connection of the building with the new piles. Figure 2.17 shows the distribution of piles (highlighted in red) in the steam plant, and the extent of the new footing (highlighted in blue) that connects them to the structure. Note that the foundation of the east wall is modified with respect to the building perimeter and moved to the right due to the existence of an electrical room in the basement. To correct the lack of number of piles right under the wall, a buttress was projected in the bottom right corner of the building.

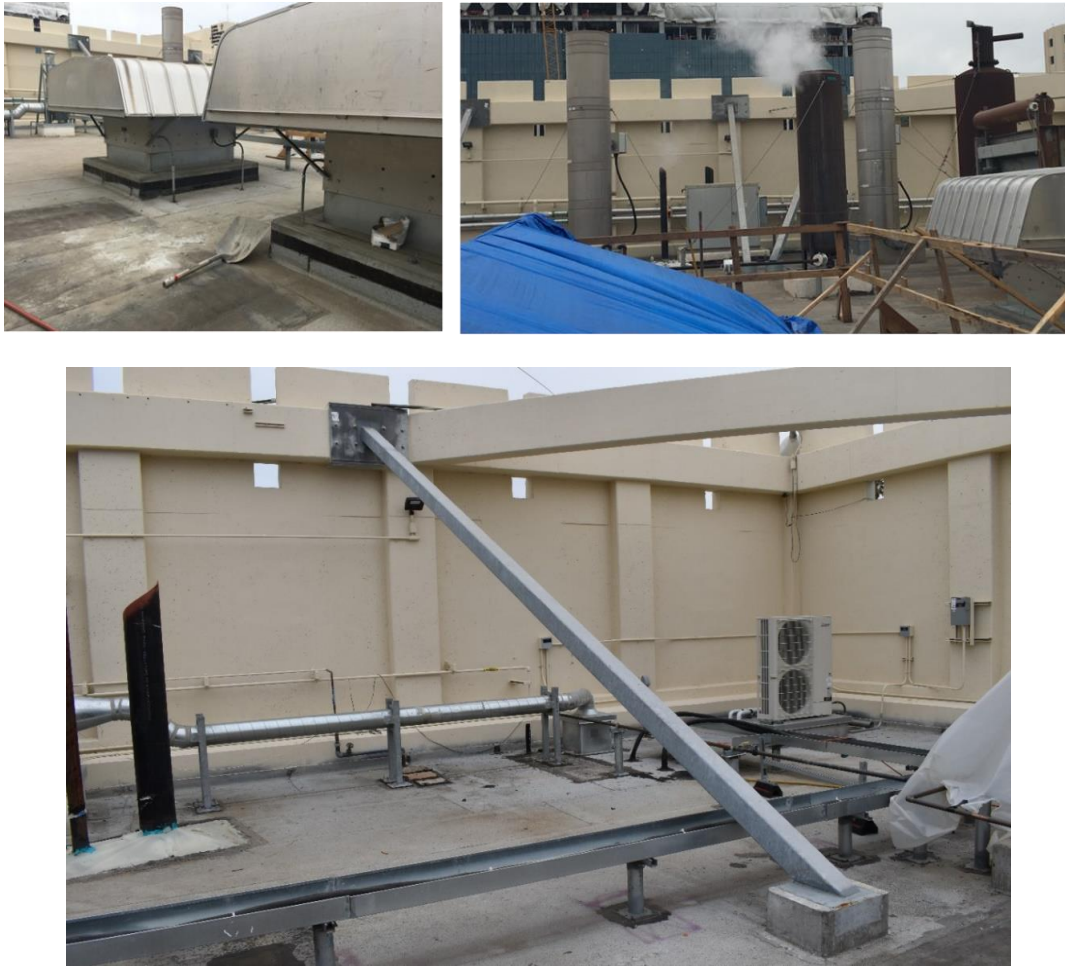
Figure 2.19. Works on the roof: Equipment bolted to the slab (top left), cable bracing of pipes in cantilever (top right) and bracing of parapets with diagonal elements (bottom).

The parapets of the structure were considerably tall. To prevent damage under earthquake forces, the original structure included a coupling beam in the entire perimeter. In the new analysis, the contribution of this beam was determined insufficient and additional bracing was required. The bracing consists of diagonal HSS members bolted to the coupling beam and to the roof slab (see Figure 2.19). These members are made of galvanized steel as they are exposed to the outdoor environment and steam coming from the plant. The connection of the bracing to the parapet is executed with a plate with stainless steel anchors embedded 7.5" [190 mm] into the reinforced concrete beam. The connection to the slab is done with two plates at both sides of the slab connected with 1" [25 mm] diameter thru bolts (see details in Figure 2.20). In the roof, all the equipment and pipes are bolted down to the roof slab.

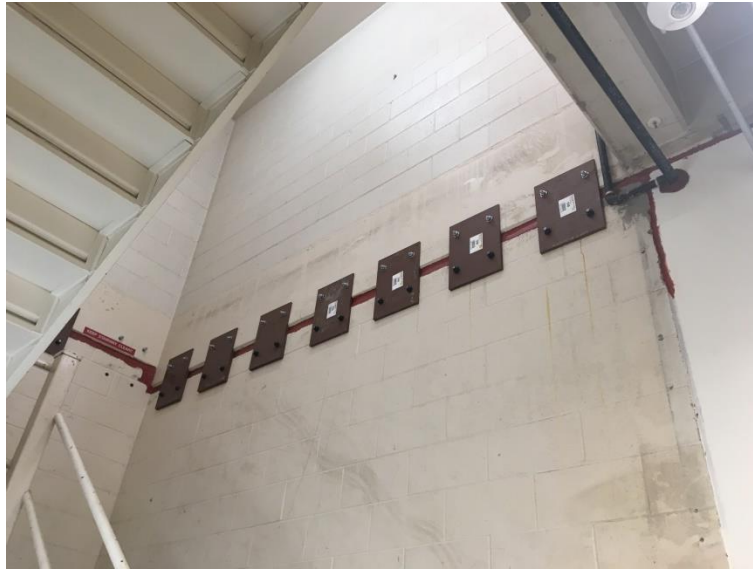
Figure 2.21. Detachment of masonry wall from the structure.

Inside the plant, there were a number of unreinforced masonry walls that were never intended nor designed to sustain shear load but could attract shear loads according to the evaluation. Such walls were demolished or, in cases where the new project required division walls, detached from the structure, as shown in Figure 2.21. Epoxy fire rated

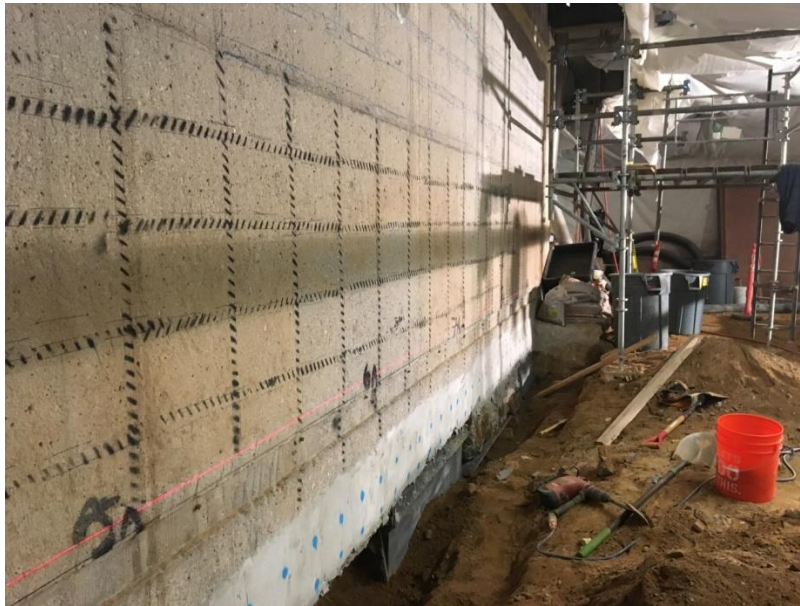
Figure 2.35. Portion of the wall that is to be increased with an additional 8 in. RC layer.

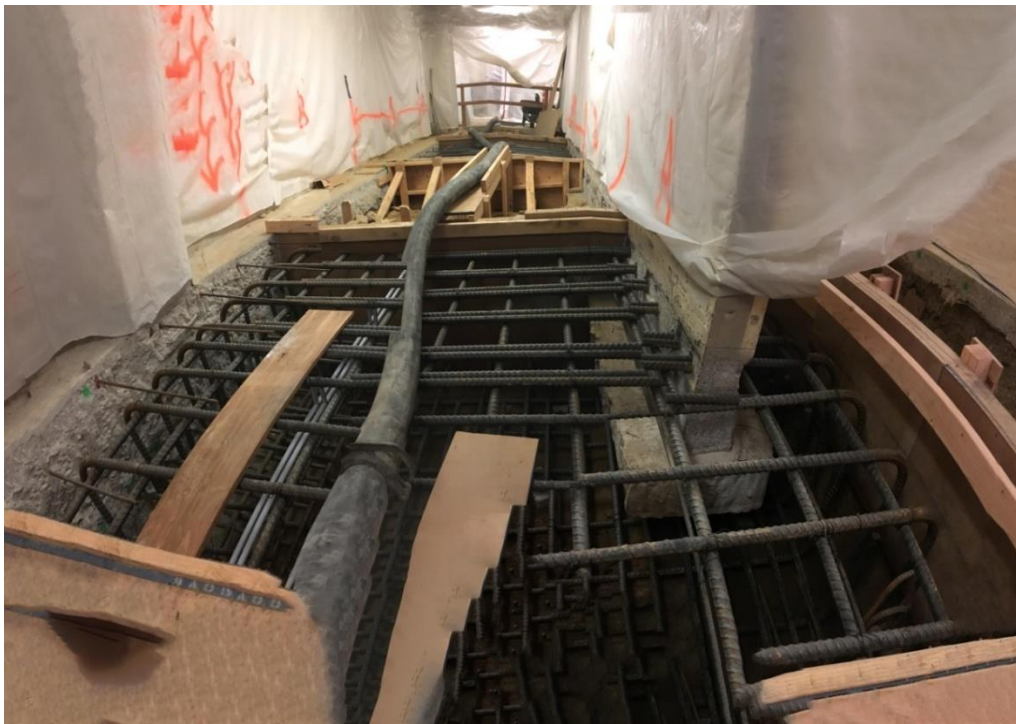
Figure 2.37. Construction of the new footing with the existing footing embedded

A special detail is included where an existing footing will be totally embedded in the new footing, for which the new footing bars will be passed through holes previously drilled in the existing footing as shown in Figure 2.36. The construction of this footing is shown in Figure 2.37. Observe the steel passing through the existing footing. In order to prevent the removal of the entire support for the existing foundation, the construction of the new foundation is specified in sequential stages.

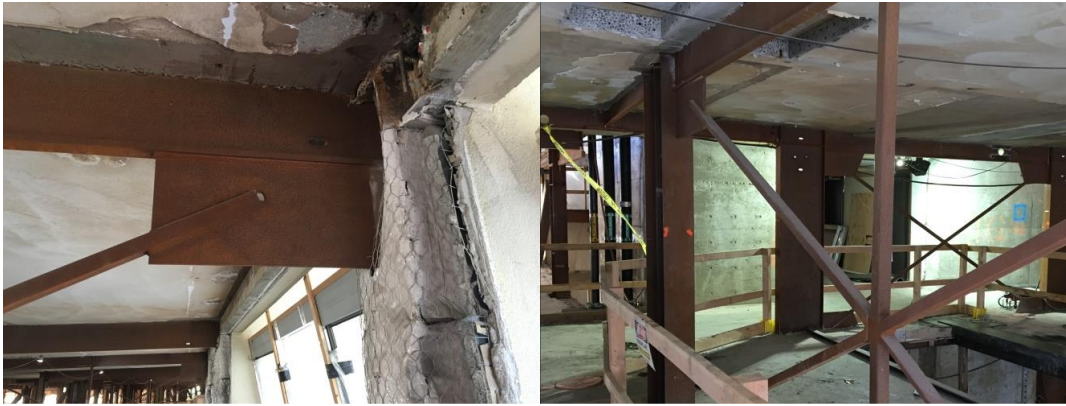
Figure 2.41. Details of connections of bracings of strips and HSS

Up to level 4, the moment frames are made of wide flange steel sections. For upper levels, the sections were made of three A-36 steel plates welded into an “I” shape with a vast variation in shapes and dimensions. The typical moment connection was made with welded cover plates and a shear plate connection with three bolts as shown in Figure 2.40. Two types of bracing were observed in the building: a) bracing made of strips of 2’’x1/4’’ [51x6.3 mm] steel plates and b) bracing made of square HSS of 2’’ [51 mm] in width. The connections of such braces were made with large gusset plates to which the strips or HSS were welded as shown in Figure 2.41.

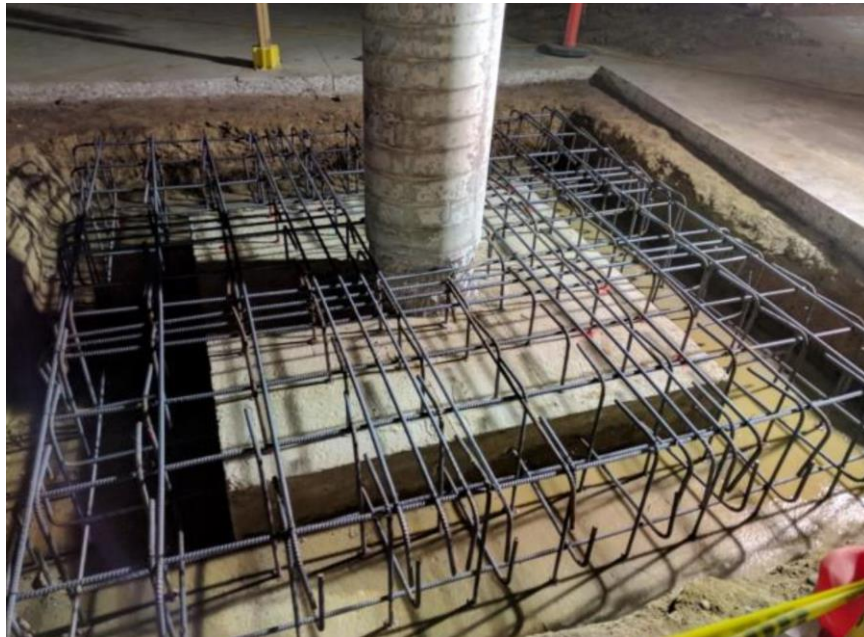
Figure 2.42. Increasing in the size of the foundation of one column.

The foundation was strengthened by increasing the size of the reinforced concrete footings as shown in Figure 2.42.

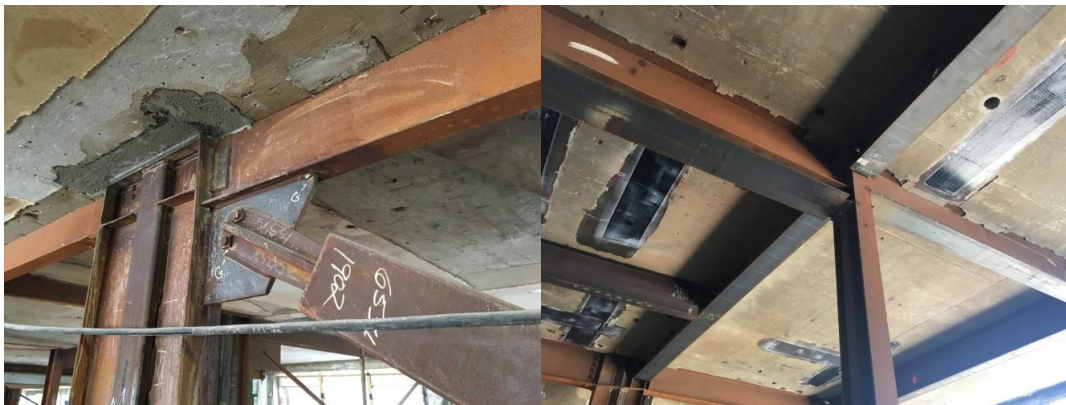
Figure 2.44. Details of strengthening in columns with welded HSS elements; beams with additional plates and the slab with FRP.

For the gravity system, added mass or altered slabs forced the localized strengthening of certain elements. Most of the localized strengthening was made by welding new elements to the steel columns, as shown in the detail of Figure 2.43(right) and Figure 2.44 (left). Note that in Figure 2.45, instead of the HSS an angle was welded to the

Fiber Reinforced Polymer (FRP) was used to strengthen slabs with insufficient tension steel, as shown in Figure 2.44 and Figure 2.45. Similarly, some reinforced concrete columns in the first floors were wrapped with FRP (see Figure 2.46). Figure 2.47 shows one squared column with a pyramidal capital which was similarly strengthened. In this case, the corners were rounded prior to the application of the FRP wrap.

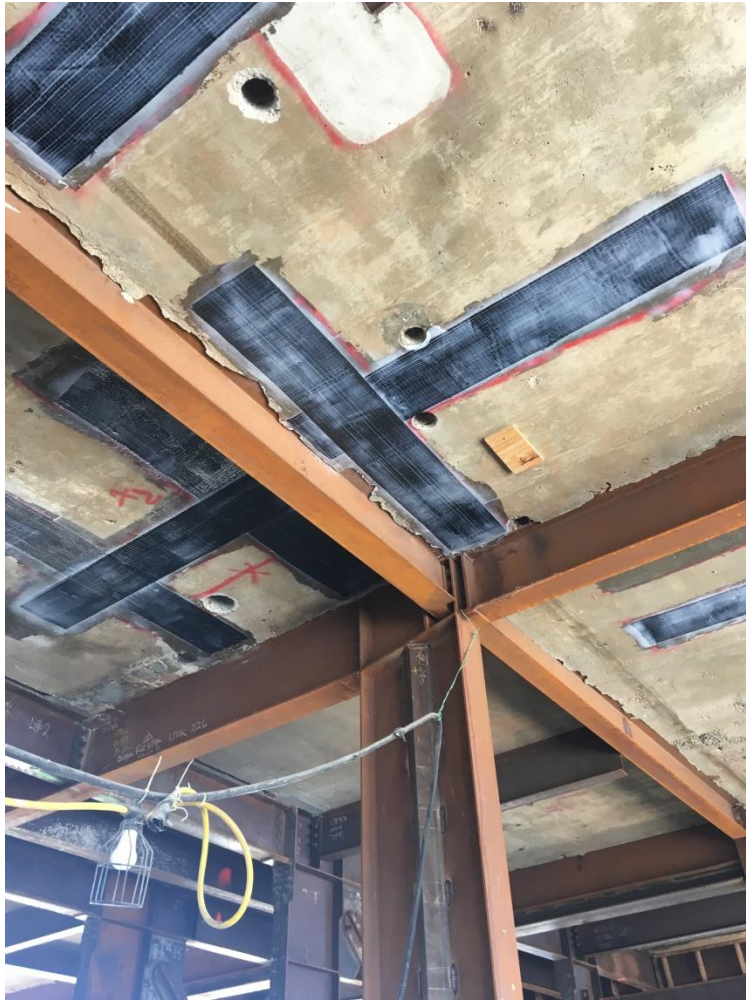
Figure 2.45. Details of strengthening in columns with welded HSS elements; beams with additional plates and the slab with FRP.

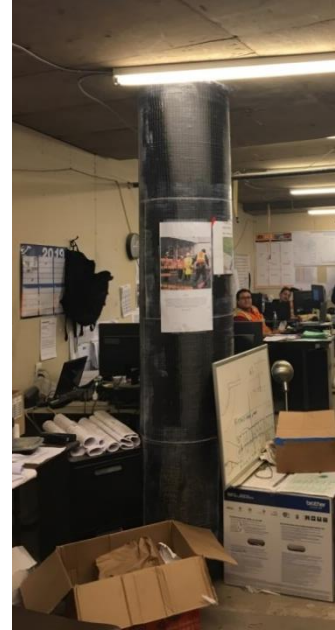
Figure 2.46. FRP strengthening of circular column in the basement

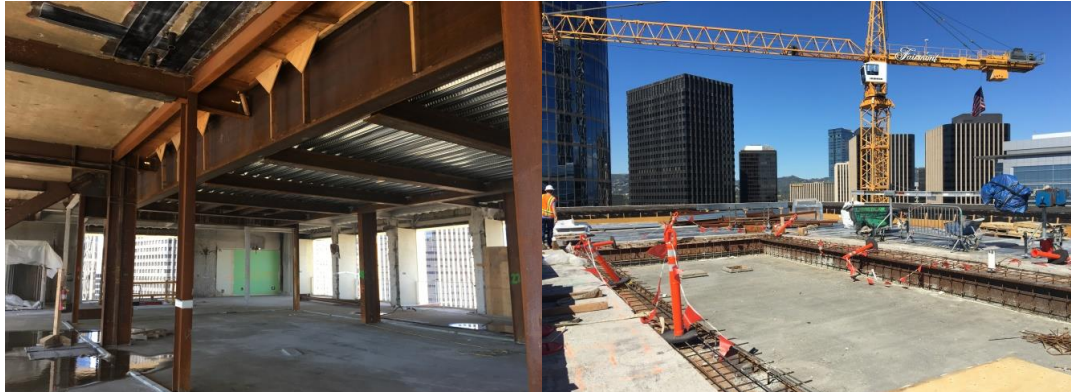
Figure 2.50. Structure for the pool on the roof. Bottom view (left) and top view (right).

Finally, a new pool was included among the new amenities of the building remodeling. As a consequence, a section of the roof was cut, and a supporting structure formed by steel beams was welded to the existing structure. A steel deck was used to support the pool, as shown in the left picture of Figure 2.50.

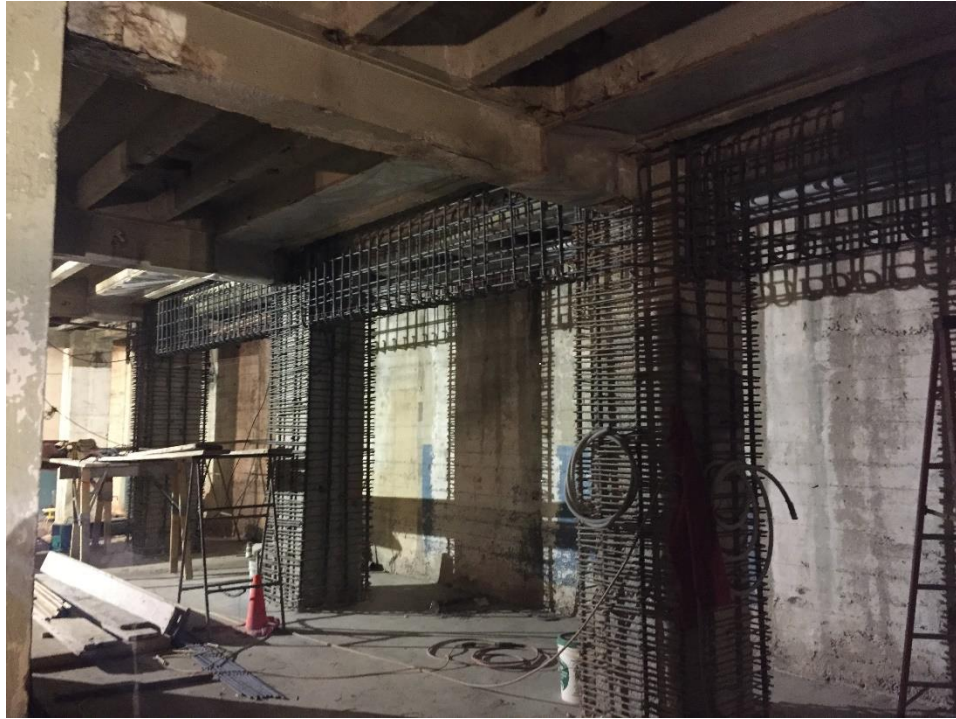
Figure 2.56. Jacketing of columns

The piers and spandrel beams of Wall A have a thickness of 16'' [40 cm], except the upper two stories which are 8'' [20 cm] thick. Instead of extending the pier into the basement level, the existing columns at this level were jacketed with reinforced concrete, as shown in Figure 2.52b and Figure 2.56. Walls E1 and E2 have a thickness of 12'' [30 cm]. Walls 4 and 9A have a thickness of 10'' [25 cm]. Wall 9D has a thickness of 12'' [30 cm]. The new walls were aligned with the existing frames and were casted against existing columns (see Figure 2.57 and Figure 2.58). The specified concrete compressive strength of the walls was 6,000 psi [41.4 MPa].

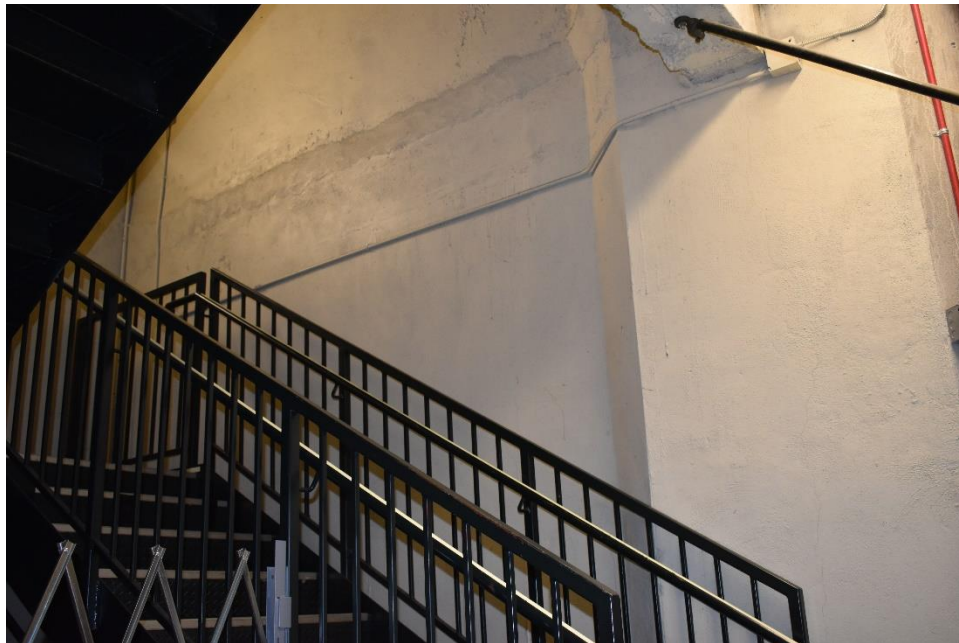
Figure 2.57. View of Shear Wall E1

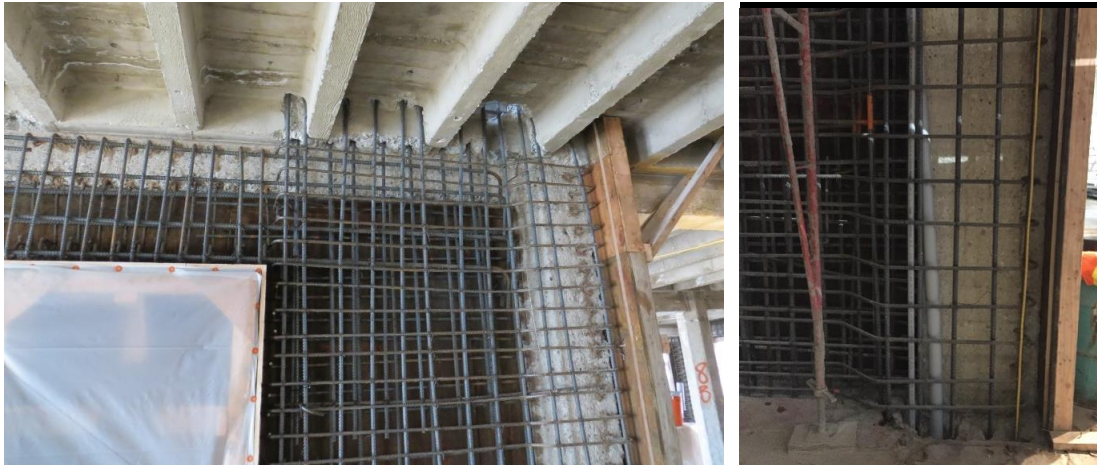
Figure 2.58. Construction of shear walls

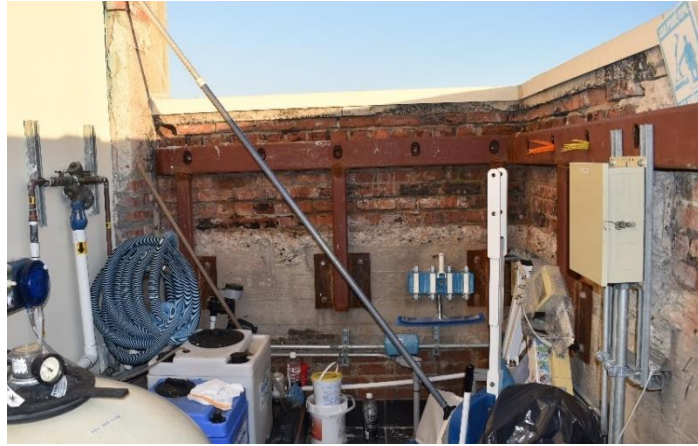
Figure 2.60. Parapet bracing

In the upper level, a new roof deck and penthouse were constructed with steel frames (Figure 2.59). Existing brick parapets were braced with steel elements as shown in Figure 2.60.
