Shoreline Types of the Upper Texas Coast: Sabine-Galveston-Freeport-Sargent Areas

Robert A. Morton and William A. White

Bureau of Economic Geology
Noel Tyler, Director
The University of Texas at Austin
Austin, Texas 78713-8924

January 1995

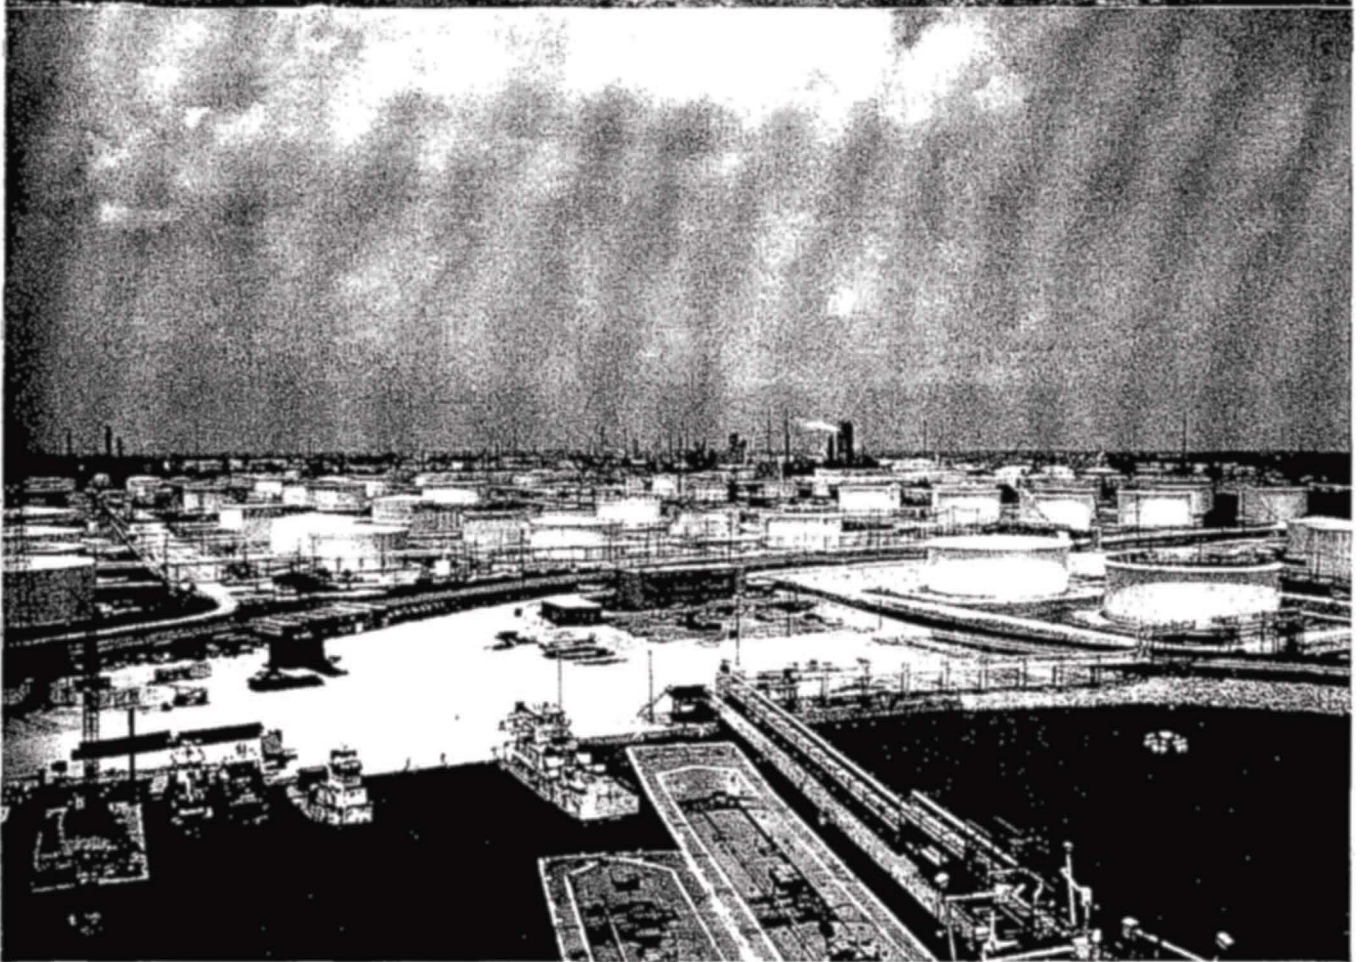
Figure 2. Examples of coastal structures (a) exposed vertical seawall at Galveston with riprap and piers, and (b) typical port facilities with bulkheads and riprap such as this refinery at Baytown.

Coastal structures along the Gulf shoreline of the upper Texas coast include seawalls, riprap, jetties, groins, and piers. Wall-type structures are the steel sheet-piles bordering Rollover Pass and the failing steel walls made of guardrails along State Highway 87 in Jefferson County. A field of groins constructed of granite blocks is also located in front of the seawall on Galveston Island and the remnants of a single concrete rubble groin and foundations of several destroyed houses are located in Jefferson County west of Sabine Pass. Riprap is also present along the toe of the Galveston seawall. Long jetties constructed of large granite blocks are located at each of the major ship channels along the Texas coast. The three jetty systems of the upper Texas coast

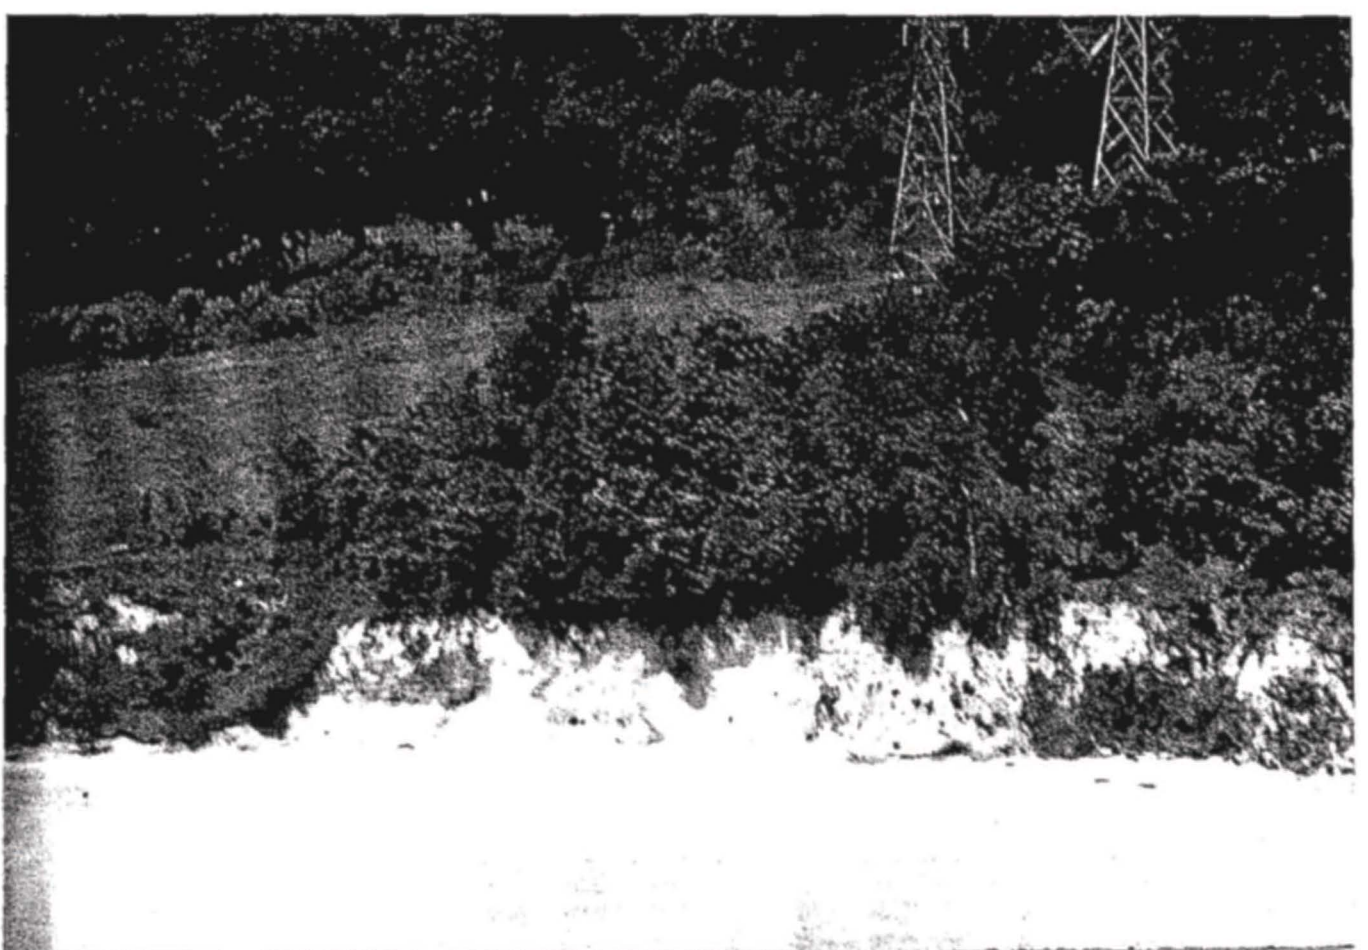
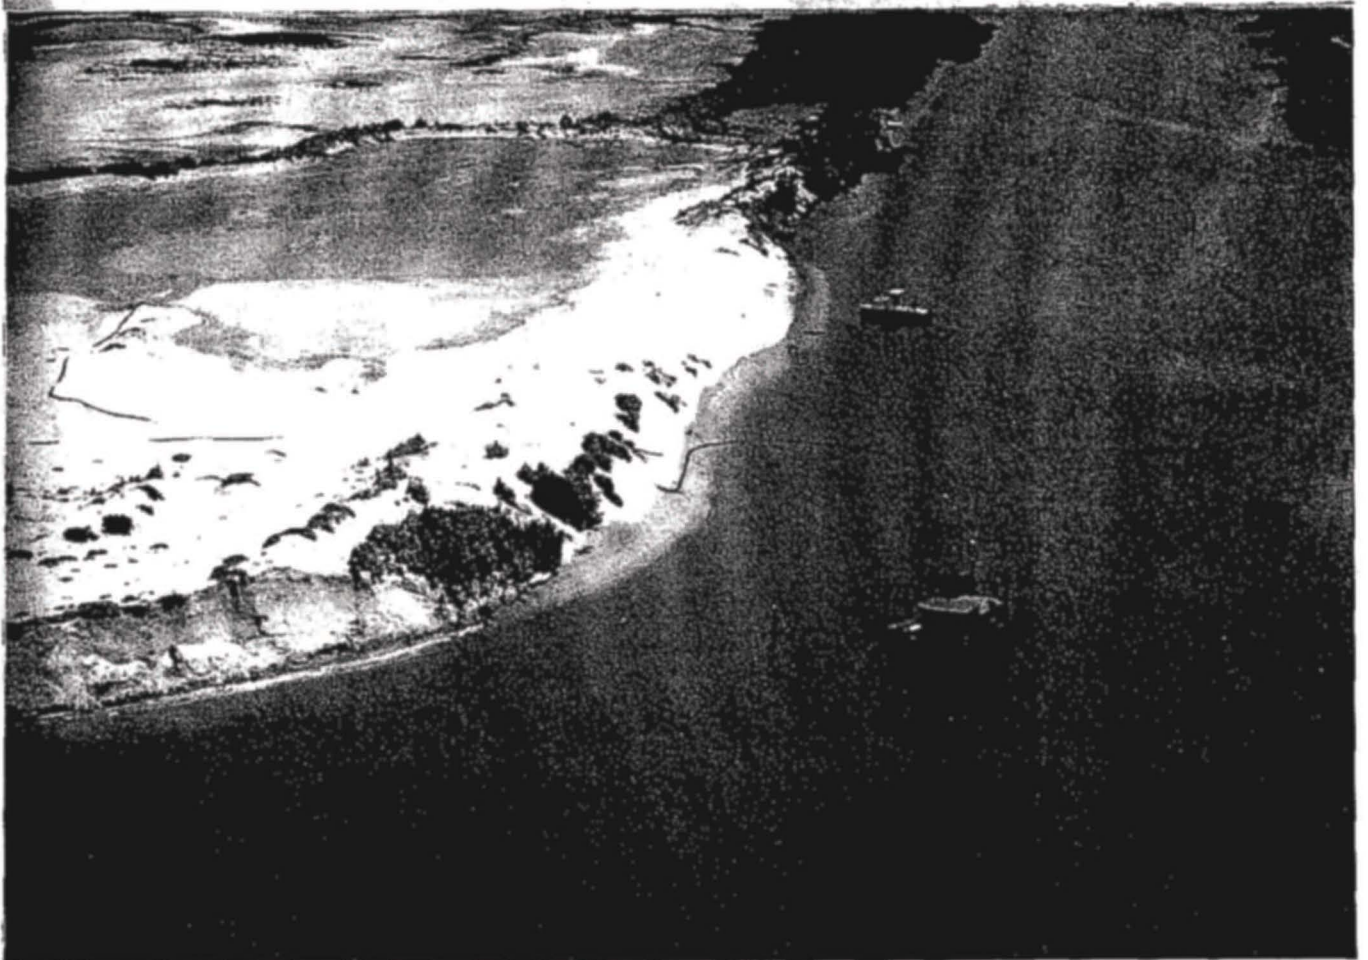
Figure 4. Examples of scarps composed of (a) clay and (b) sand.

Some bay shorelines are characterized by relatively steep slopes composed of either clay or sand, that are covered with vegetation. The steep topographic gradient in such areas is manifested by relatively high nearshore elevations, which support upland to transitional vegetation rather than emergent marsh vegetation. Although there may be some fringing marsh along the water's

edge, it is considered too narrow and not important enough to delineate on the maps. These shorelines were classified as either sheltered scarps (8C), clay scarps and steep slopes (2A), or sand scarps and steep slopes (3B).

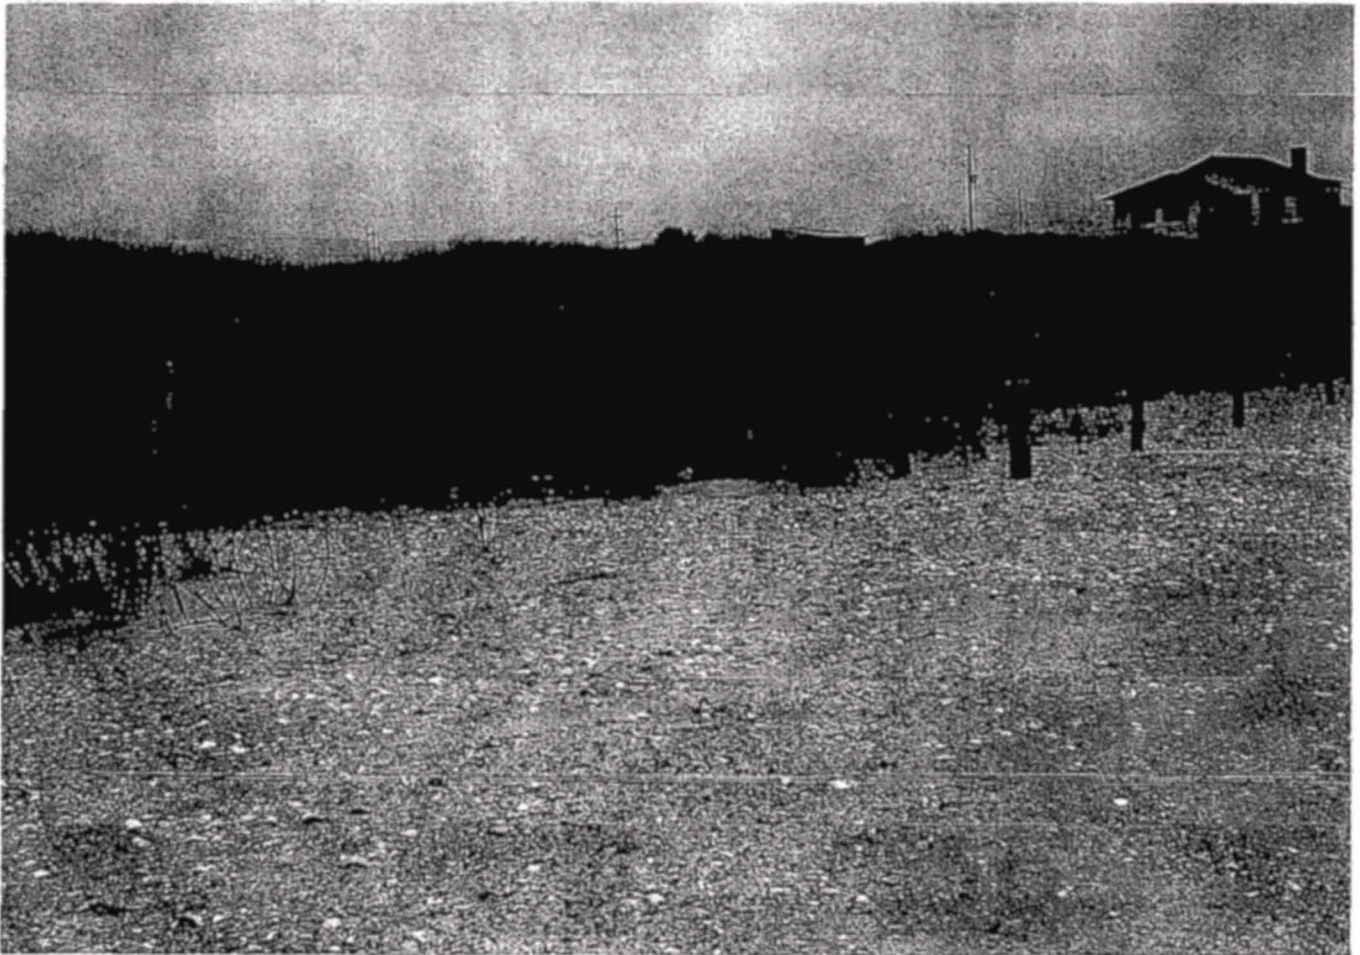
Figure 7. Example of a mixed sand and gravel (shell) beach.

The mixed sand and gravel (shell) beach classification (ESI Ranking 5) includes those beaches composed mostly of fine-grained sand that also contain a moderately high percentage of shell (Figure 7). These beaches occur on Bolivar Peninsula between Crystal Beach and Rollover Pass, between High Island and Sea Rim State Park, and along spoil islands in East and West Bays and Galveston Bay.

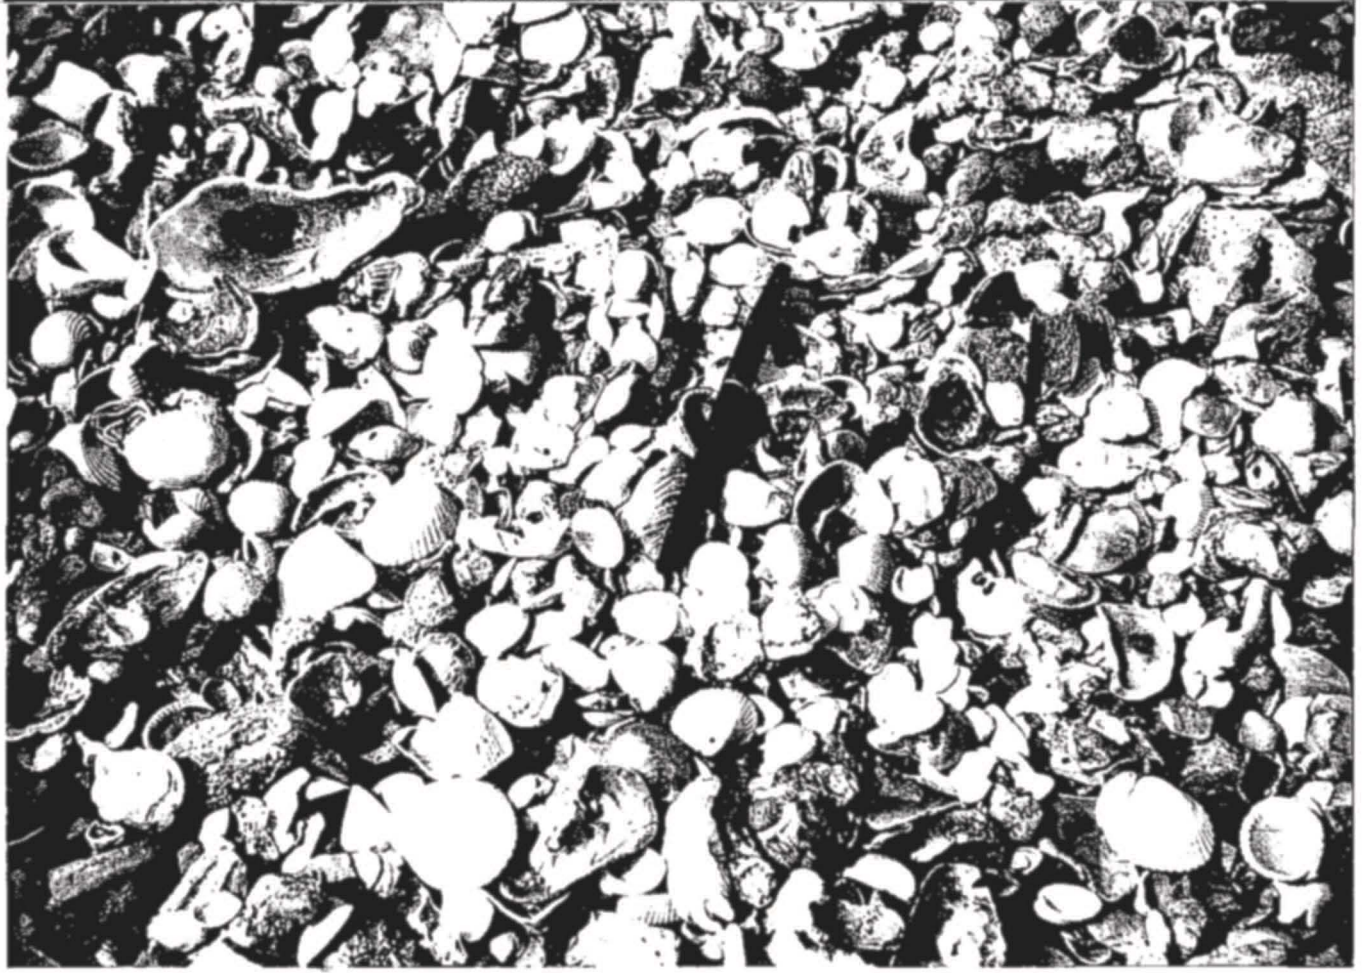
Figure 8. Example of gravel (shell) beaches (a) aerial view and (b) ground view.

The environmental sensitivity of gravel (shell) beaches is moderate due to the use of this shore type by estuarine organisms and extensive washover terrace development. Oil typically stains and coats the shell hash and whole shells composing the beach. Oil penetration is high due to the porous beach character created by the shell material. This beach type quickly turns into an asphalt pavement under heavy oiling conditions. Shell beaches have poor trafficability due to the low bearing strength and steep beach face. Accessibility to shell beaches in Texas is variable

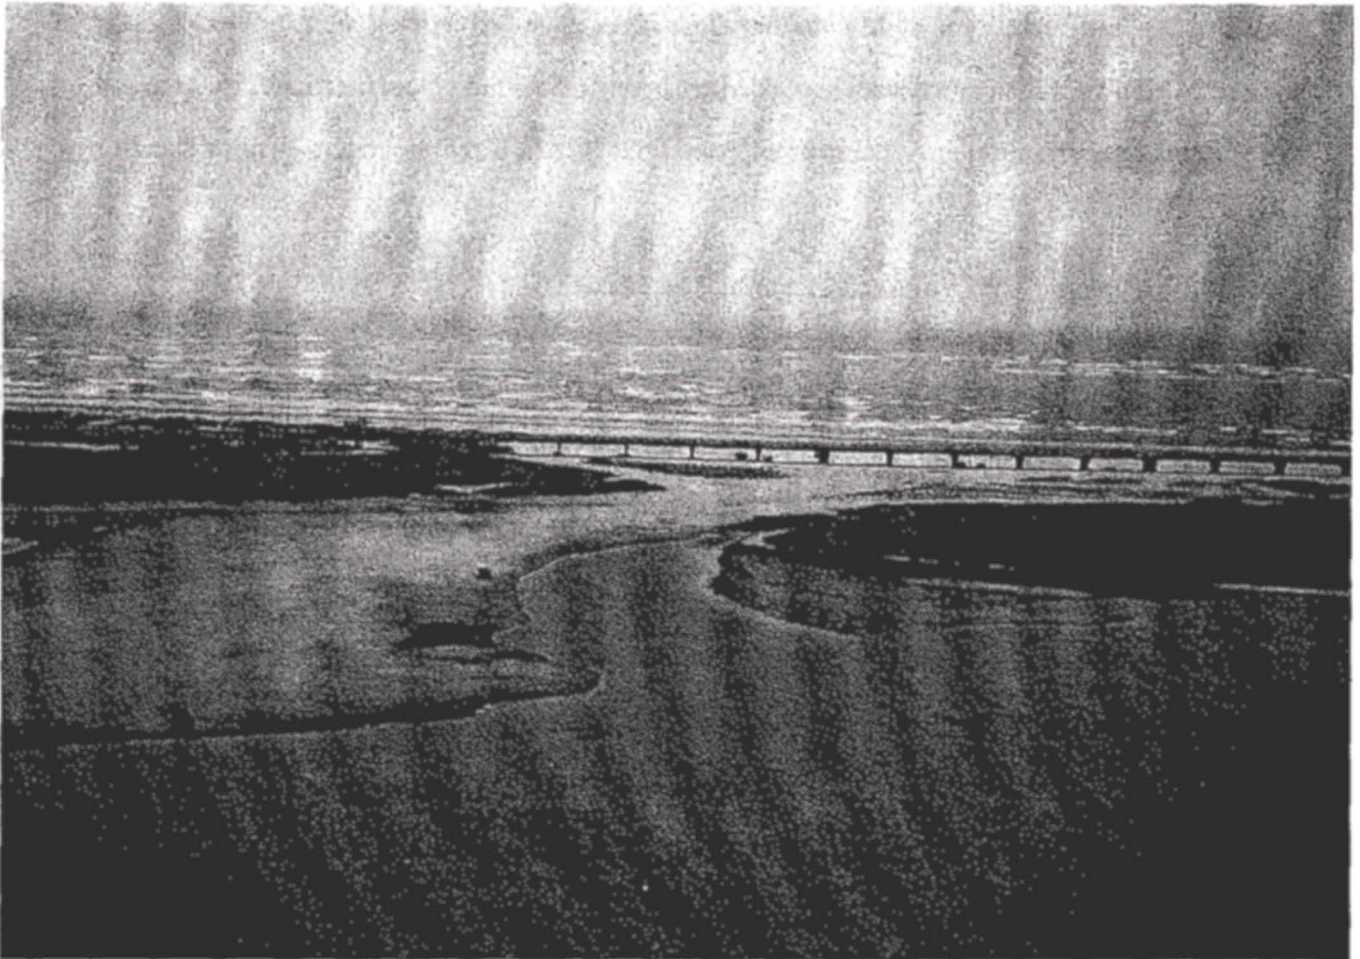
Figure 9. Example of an exposed tidal flat.

The exposed tidal flat classification (ESI Ranking 7) is used to describe broad intertidal areas normally consisting of fine sand and minor amounts of shell. The mean grain size ranges between 0.0625 and 0.200 mm. Exposed tidal flats are typically found in association with barrier islands (Figure 9) and tidal inlet systems. In Texas, tidal flats can be either submerged or exposed depending on water level, wind strength, and wind direction. Due to the low flat gradient, slight changes in water levels can produce significant changes in position where the water meets the shore. Salt marsh vegetation often develops along the upper intertidal areas of the exposed flats.

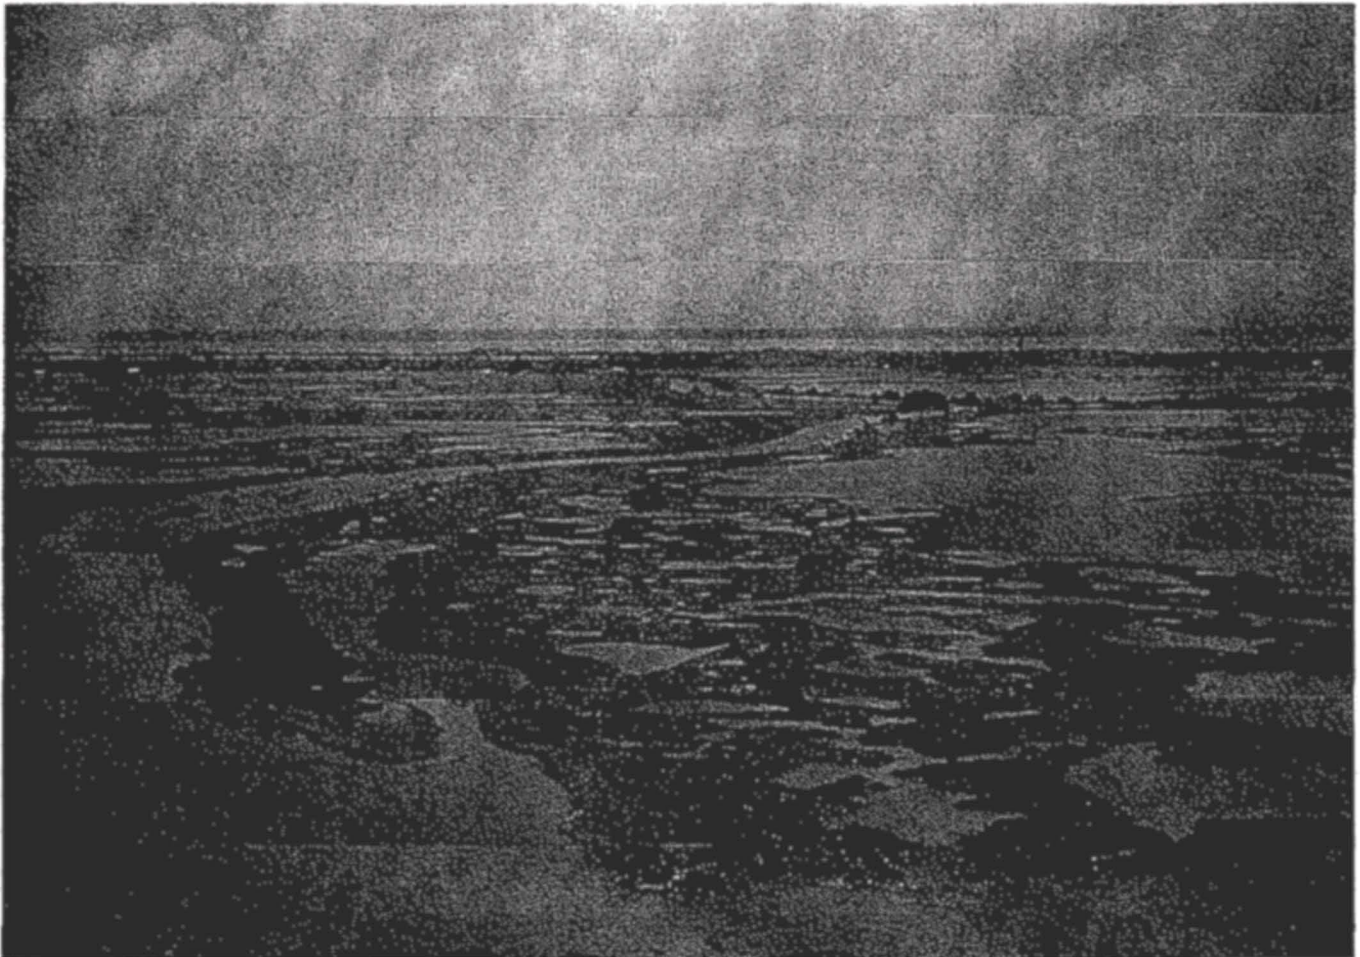
Figure 11. Example of a salt- and brackish-water marsh.

The salt- and brackish-water marsh classification (ESI Ranking 10A) describes the wet grasslands vegetated by plant species that tolerate salt and brackish water. The sediments of salt- and brackish-water marshes commonly are highly organic and muddy except on the margins of barrier islands where sand is abundant. Salt- and brackish-water marshes are extensive around the margins of the bays in Texas (Figure 11).

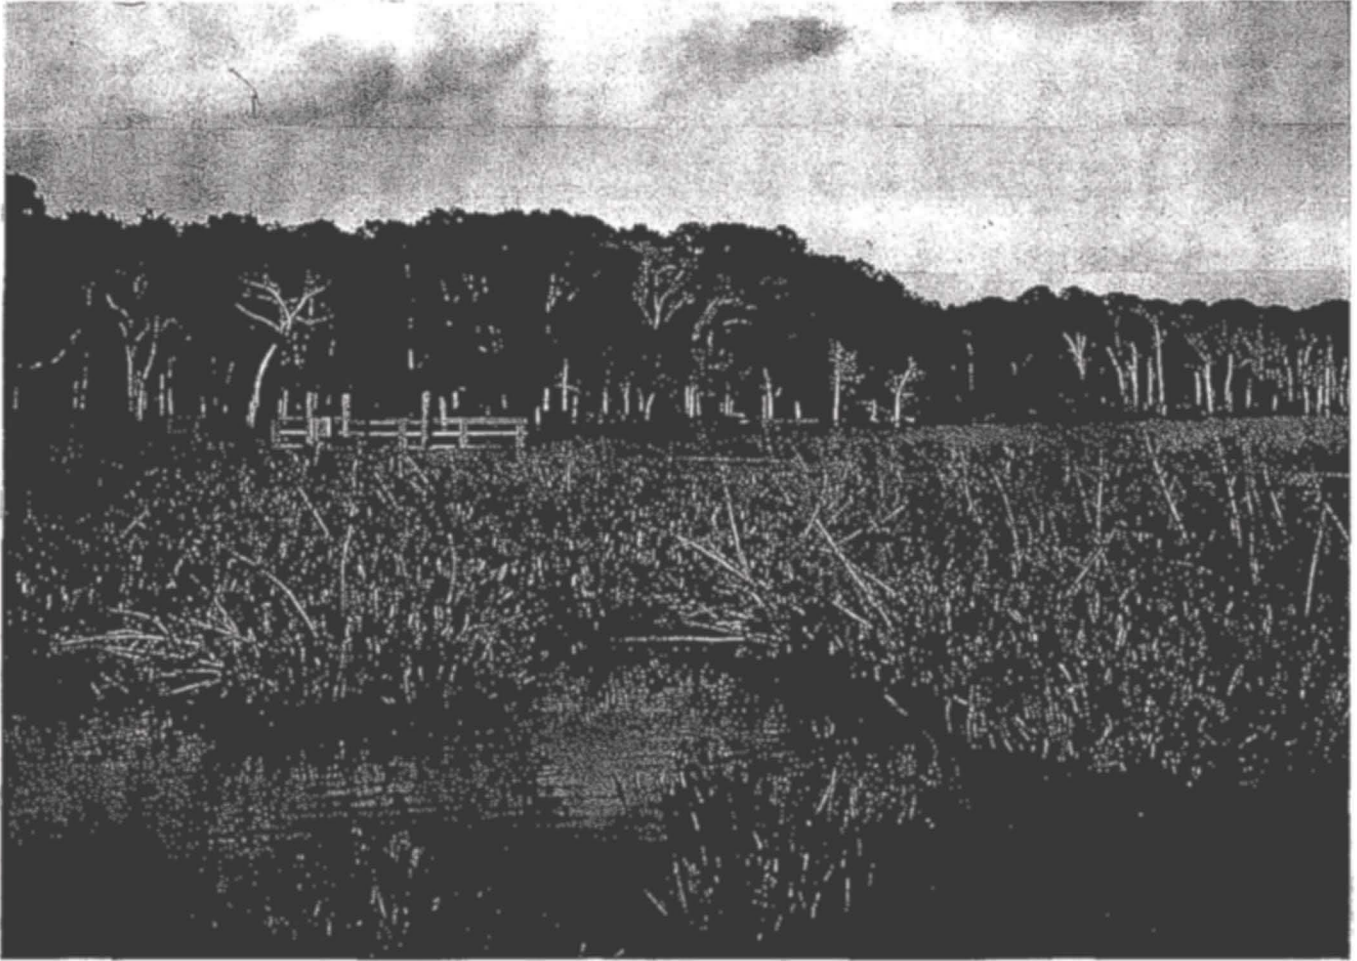
Figure 12. Example of a fresh-water marsh.

The fresh-water marsh classification (ESI Ranking 10B) is used to describe the densely vegetated coastal interior that is not inundated by salt water and the sediments typically are highly organic and muddy. Fresh-water marshes are characterized by high biodiversity and rich wetland habitat. This shoreline type is found within the river valleys and along the uplands at elevations higher than the tidal range (Figure 12).

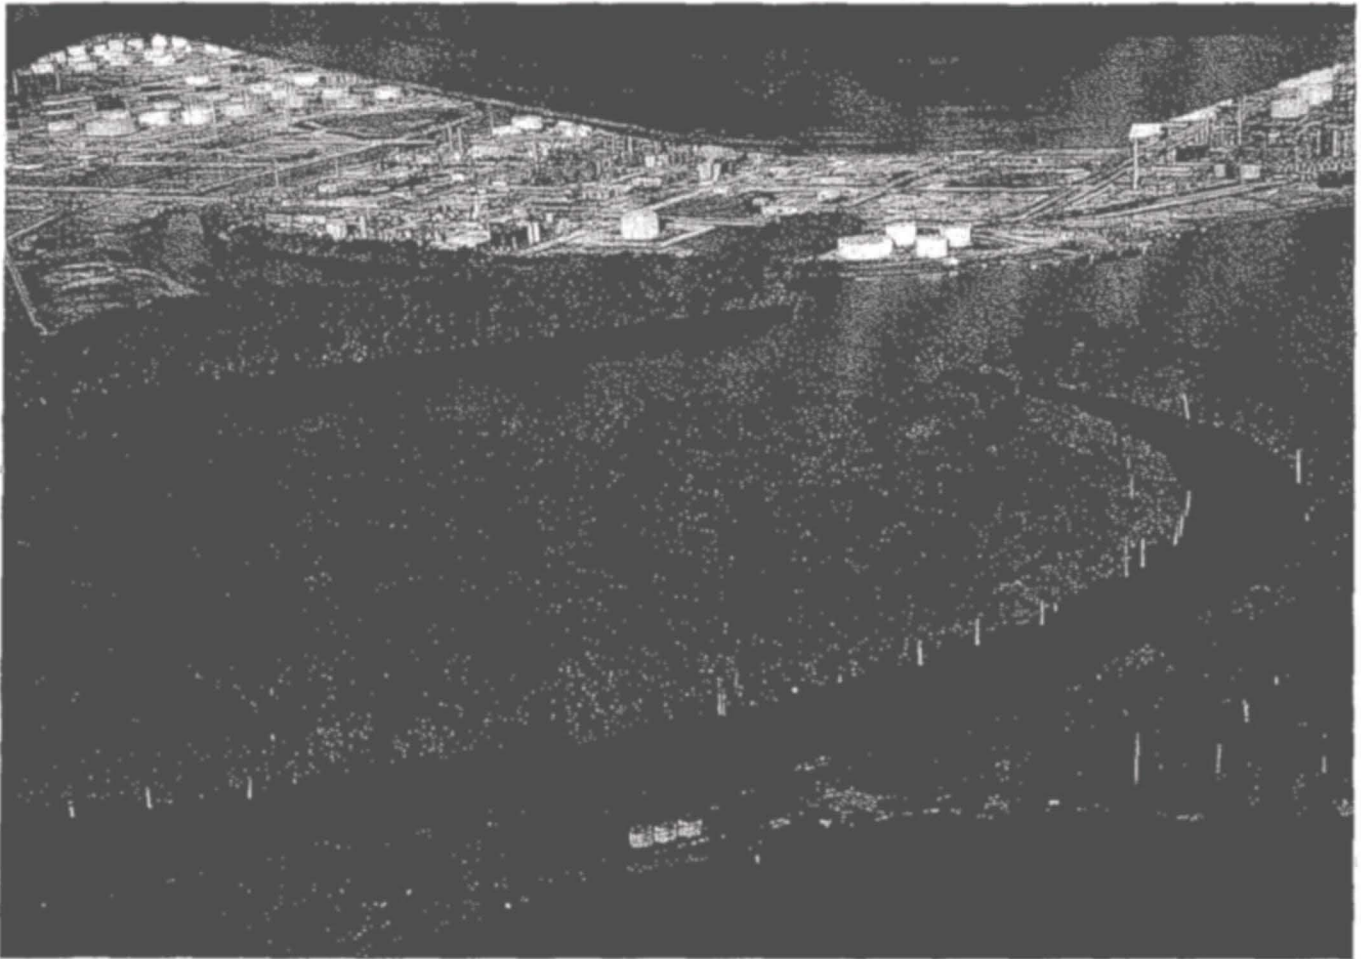
Figure 13. Example of a fresh-water swamp.

The fresh-water swamp classification (ESI Ranking 10C) describes shores that consist of shrubs and hardwood forested wetlands (Figure 13). This shoreline type, which is essentially a flooded forest, is common in the river valleys of the upper Texas coast. The sediments within the interior swamps tend to be silty clay and contain a large amount of organic debris.
